# UTAH STATE CAPITOL ARCHITECTURE: EXTERIOR SURVEY REPORT

ELEVATION LOCATION: LOWER DRUM

Survey Date: 4/26/00

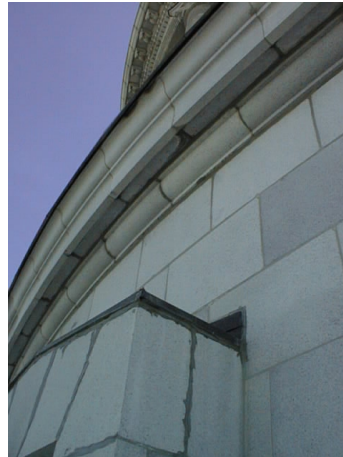
**Grid:** H/E 52; H/W 51

**Description:** Drum wall

**Location:** North Elevation

**Condition:** CR

Cracked element

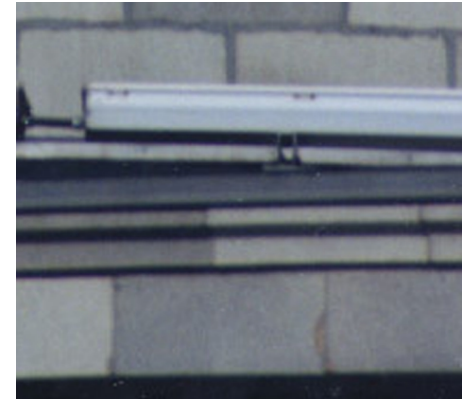
**Grid:** I

**Description:** Drum wall

**Location:** North Elevation

**Condition:** BR

Broken, severely cracked or chipped

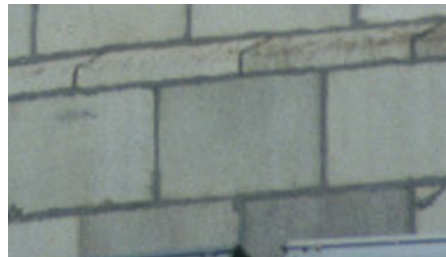
**Grid:** J/I, E 5

**Description:** Drum wall

**Location:** North Elevation

**Condition:** PAT

Poor quality, non-matching patch

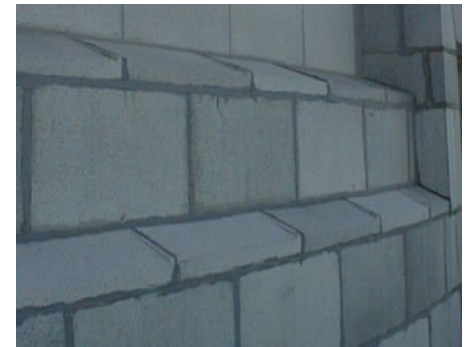
**Grid:** I/E 7

**Description:** Drum wall

**Location:** North Elevation

**Condition:** J

Mortar joint with missing or loose mortar

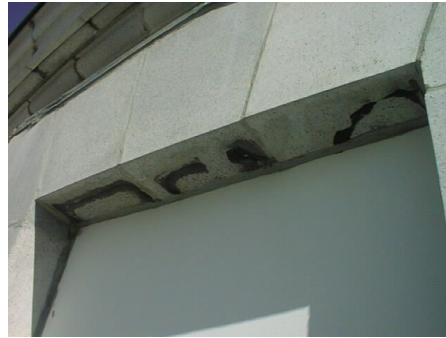
**Code:** EX-028**Description:** Drum wall**Location:** North Elevation above door**Grid:** J/I, CL**Condition:** STSignificant Staining; may  
indicate rusted connector**Comments:**

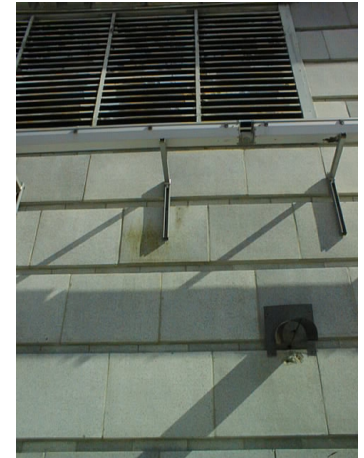
**Code:** EX-028**Description:** Drum wall**Location:** North Elevation**Grid:** H/E 15, W-15**Condition:** INTIntrusive, non-original, non-  
essential element**Comments:** pipe bracket

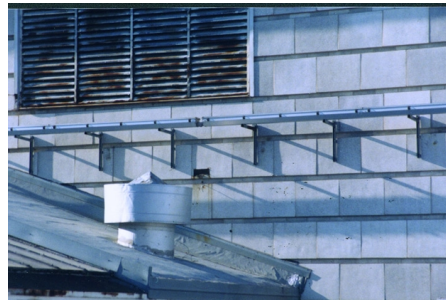
**Code:** EX-028**Description:** Drum wall**Location:** North Elevation**Grid:** H/typical**Condition:** INTIntrusive, non-original, non-  
essential element**Comments:** metal anchor, screws for lights

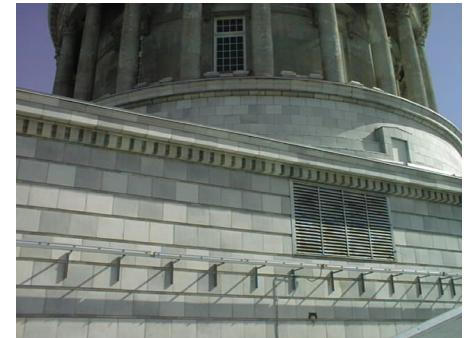
**Code:** EX-028**Description:** Drum wall**Location:** South Elevation at pipe**Grid:****Condition:** NONon-original, incompatible but  
essential elements**Comments:**

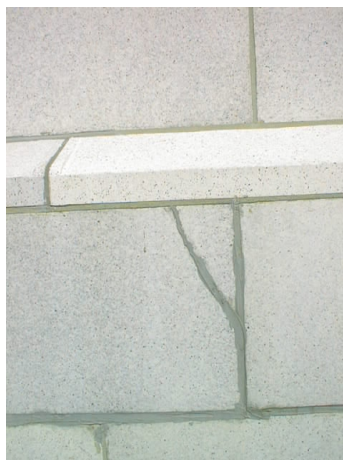
**Grid:** H typical

**Description:** Drum wall

**Location:** East Elevation

**Condition:** CR

Cracked element

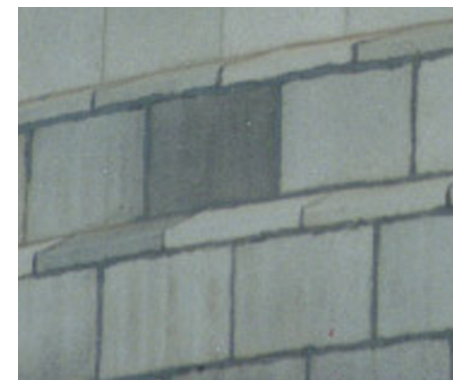
**Grid:** I/S 4, S 7, S 19; J/L 19, L 18

**Description:** Drum wall

**Location:** East Elevation

**Condition:** J

Mortar joint with missing or loose mortar

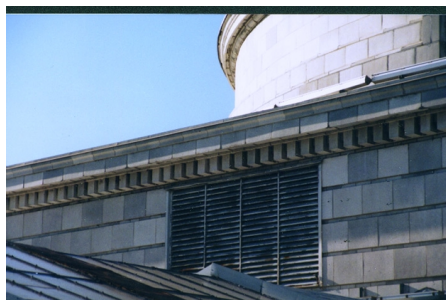
**Grid:** I/S 4

**Description:** Drum wall

**Location:** East Elevation

**Condition:** CR

Cracked element

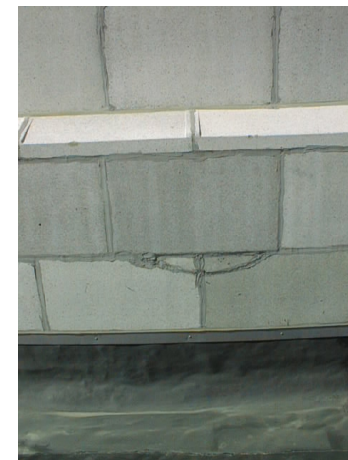
**Grid:** I/N 22, H/N 48, H/S 48

**Description:** Drum wall

**Location:** East Elevation

**Condition:** CR

Cracked element

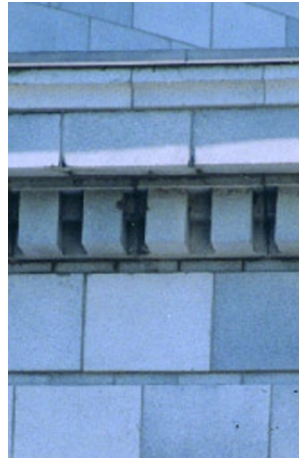
**Grid:** I/N 3, I/N 30..

**Description:** Drum wall

**Location:** East Elevation

**Condition:** BR

Broken, severely cracked or  
chipped

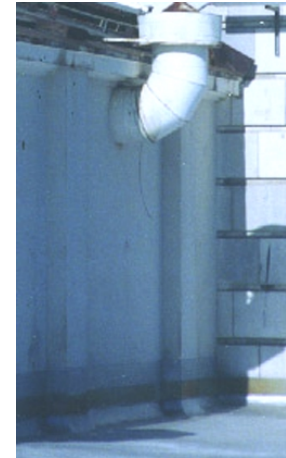
**Grid:** H/S-50, N-50

**Description:** Drum wall

**Location:** East elevation

**Condition:** CR

Cracked element

**Comments:** CR--12"

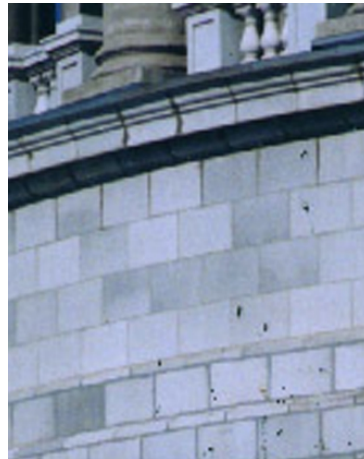
**Grid:** I/S-10

**Description:** Drum wall

**Location:** East elevation

**Condition:** CR

Cracked element

**Comments:** CR

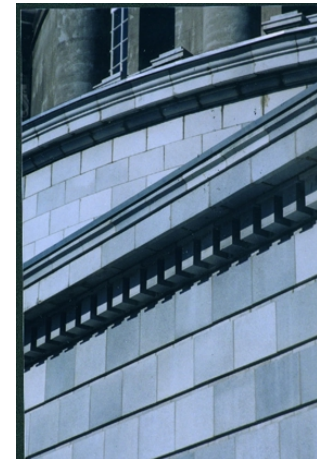
**Grid:** I/S-19, S-7

**Description:** Drum wall

**Location:** East elevation

**Condition:** J

Mortar joint with missing or loose  
mortar

**Comments:** J

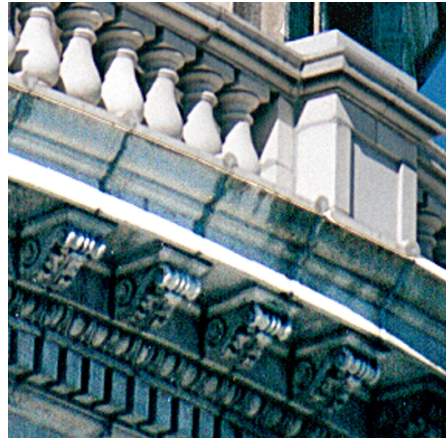
**Grid:** J/E 25; J/CL

**Description:** Drum cornice

**Location:** North Elevation

**Condition:** BR

Broken, severely cracked or  
chipped

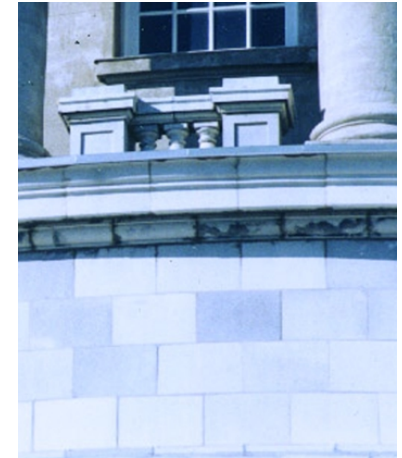
**Grid:** J/E 25

**Description:** Drum cornice

**Location:** North Elevation

**Condition:** J

Mortar joint with missing or loose  
mortar

**Comments:** (typ) E-21, W-7, W-15, U-26

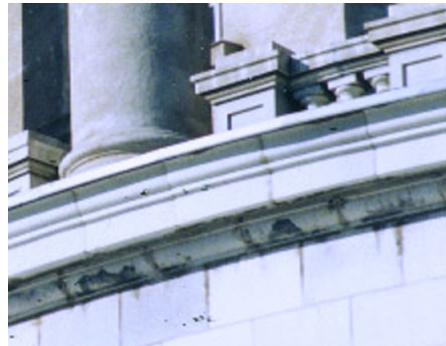
**Grid:** J/E 12, E 7

**Description:** Drum cornice

**Location:** North Elevation

**Condition:** CR

Cracked element

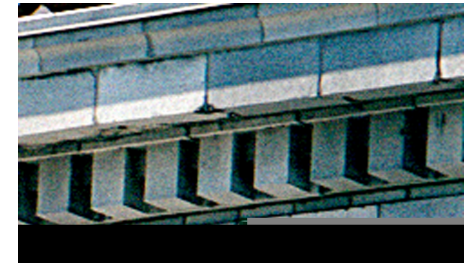
**Grid:** I, typical

**Description:** Drum cornice

**Location:** North Elevation

**Condition:** J

Mortar joint with missing or loose  
mortar

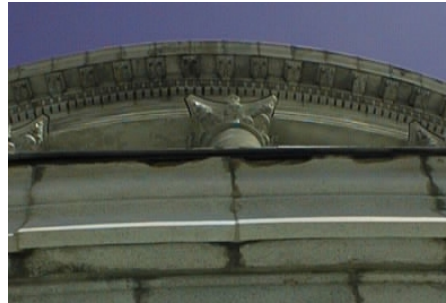
**Grid:** J/CL to W 25

**Description:** Drum cornice

**Location:** North Elevation

**Condition:** BR

Broken, severely cracked or  
chipped

**Comments:** all the way around: South, 7  
breaks; East, 4.

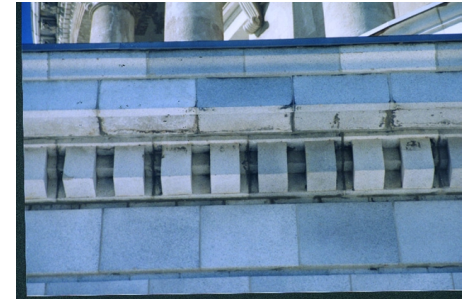
**Grid:** I/S 49

**Description:** Drum cornice

**Location:** East Elevation

**Condition:** CR

Cracked element

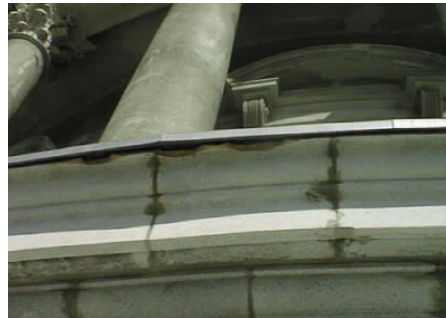
**Grid:** J/S 25, S19

**Description:** Drum cornice

**Location:** East Elevation

**Condition:** BR

Broken, severely cracked or  
chipped

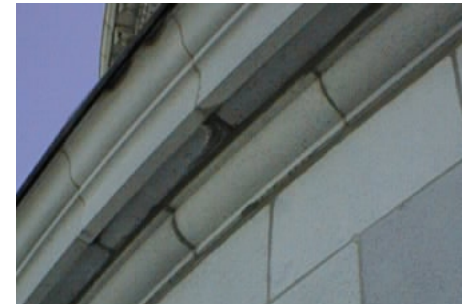
**Grid:** J/N 4

**Description:** Drum cornice

**Location:** East Elevation

**Condition:** J, CK

Mortar joint damage, covered  
poorly with caulking

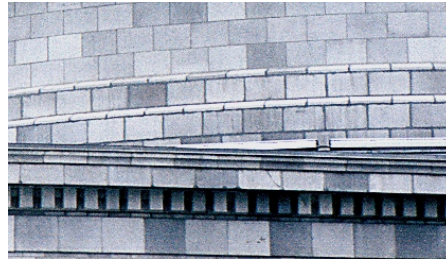
**Code: EX-029****Description: Drum cornice****Location:** West Elevation**Grid:** I/N 50**Condition:** CR

Cracked element

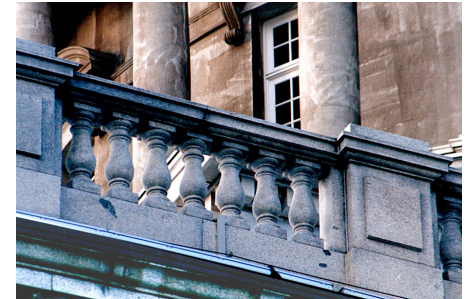
**Comments:****Code: EX-030****Description: Drum balustrade****Location:** East Elevation**Grid:** J/typical**Condition:** J

Mortar joint with missing or loose mortar

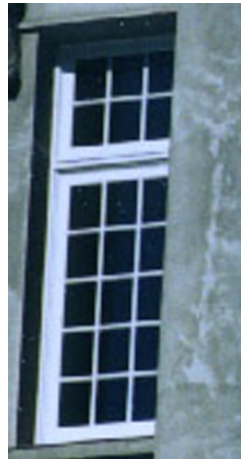
**Comments:** expansion joint**Code: EX-037****Description: Window trim****Location:** East Elevation**Grid:** J/typical**Condition:** P

Paint missing or damaged

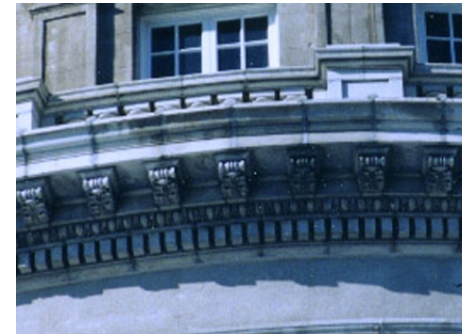
**Comments:** peeling**Code: EX-039****Description: Entablature****Location:** East Elevation**Grid:** L/S 4, N 4**Condition:** BR

Broken, severely cracked or chipped

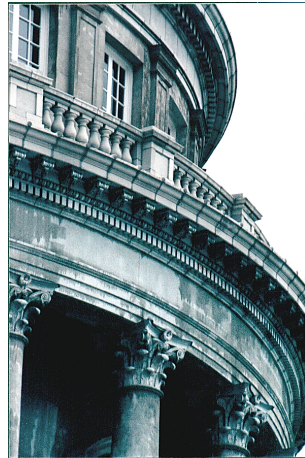
**Grid:** L/N 15, N 6, S 10, S 15

**Description:** Entablature

**Location:** West Elevation

**Condition:** ST

Significant Staining; may  
indicate rusted connector

**Comments:** (yellow)

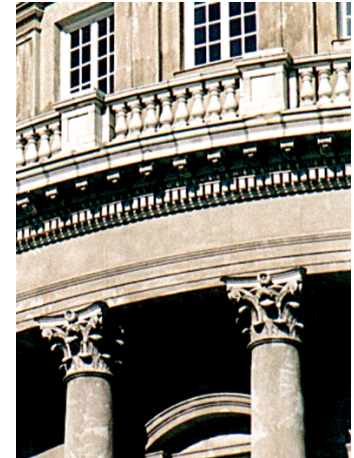
**Grid:** L

**Description:** Cornice

**Location:** North Elevation

**Condition:** J, ST

Mortar joint damage and  
significant staining

**Comments:** J typical; ST: E-7, W-7.

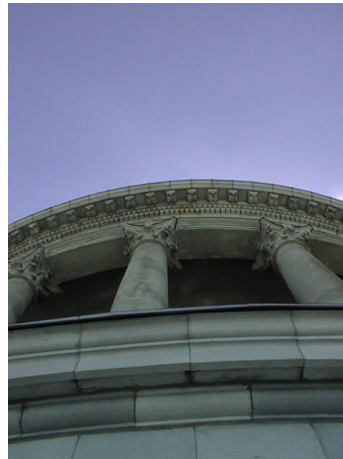
**Grid:** L/W 21 and W 7

**Description:** Cornice

**Location:** South Elevation

**Condition:** ST

Significant Staining; may  
indicate rusted connector

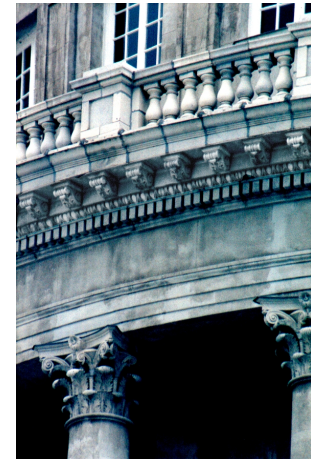
**Grid:** L/S 33

**Description:** Cornice

**Location:** West Elevation

**Condition:** CR

Cracked element

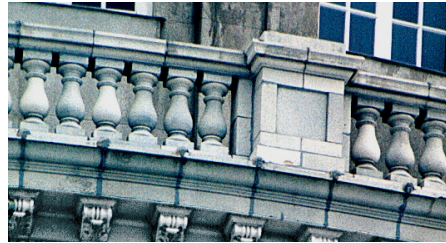
**Grid:** J/ typical

**Description:** Balustrade

**Location:** West Elevation

**Condition:** BR

Broken, severely cracked or  
chipped

**Comments:** chipped; small chips typical

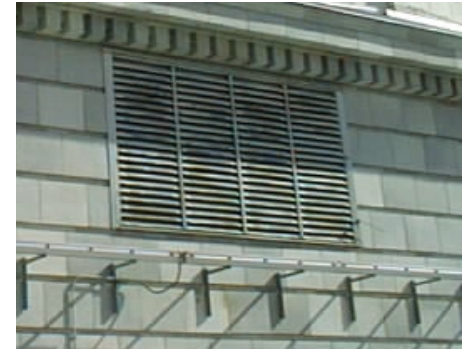
**Grid:** I/E 15

**Description:** Mechanical grille

**Location:** North Elevation

**Condition:** O

Other (describe)

**Comments:** paint on metal; also stain at bottom

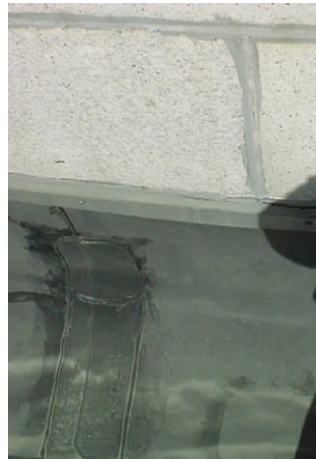
**Grid:** I/E 40

**Description:** Flashing

**Location:** North Elevation

**Condition:** BR

Broken, severely cracked or  
chipped

**Comments:** protruding

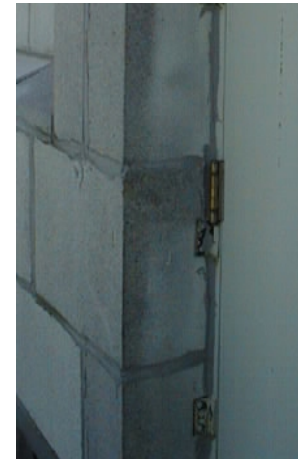
**Grid:** I/CL

**Description:** Door

**Location:** South Elevation

**Condition:** MT

Metal damage

**Comments:** rusted hinges (new)
